Report No. 79-2

Demonstration of
MARSH TURBO THRUSH
to Deliver Pesticides
to Coniferous Forests

DECEMBER 1978

Methods Application Group
Forest Insect and Disease Management
Forest Service, USDA
Davis, California

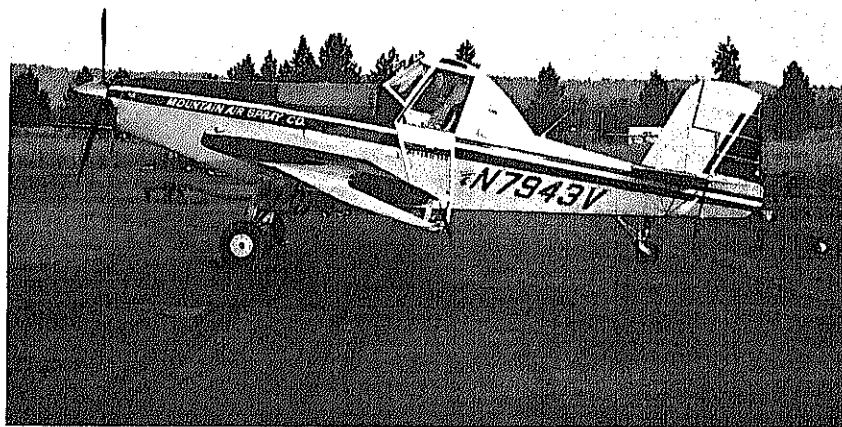
Figure 1. Marsh Turbo Thrush. Note 400-gallon hopper forward of cockpit. Turbo Thrush test, Idaho 1978.

The Marsh Turbo Thrush is the Rockwell Thrush Commander agricultural spray aircraft converted to jet prop. Marsh Aviation of Mesa, Arizona, performs the conversion and markets the aircraft (Figs. 1 and 2).

One Marsh Turbo Thrush owned by Mountain Air Spray Company, Craig, Colorado. This fixed-wing jet-prop powered (Garrett TPE-331) spray aircraft was the primary test vehicle (Fig. 1).

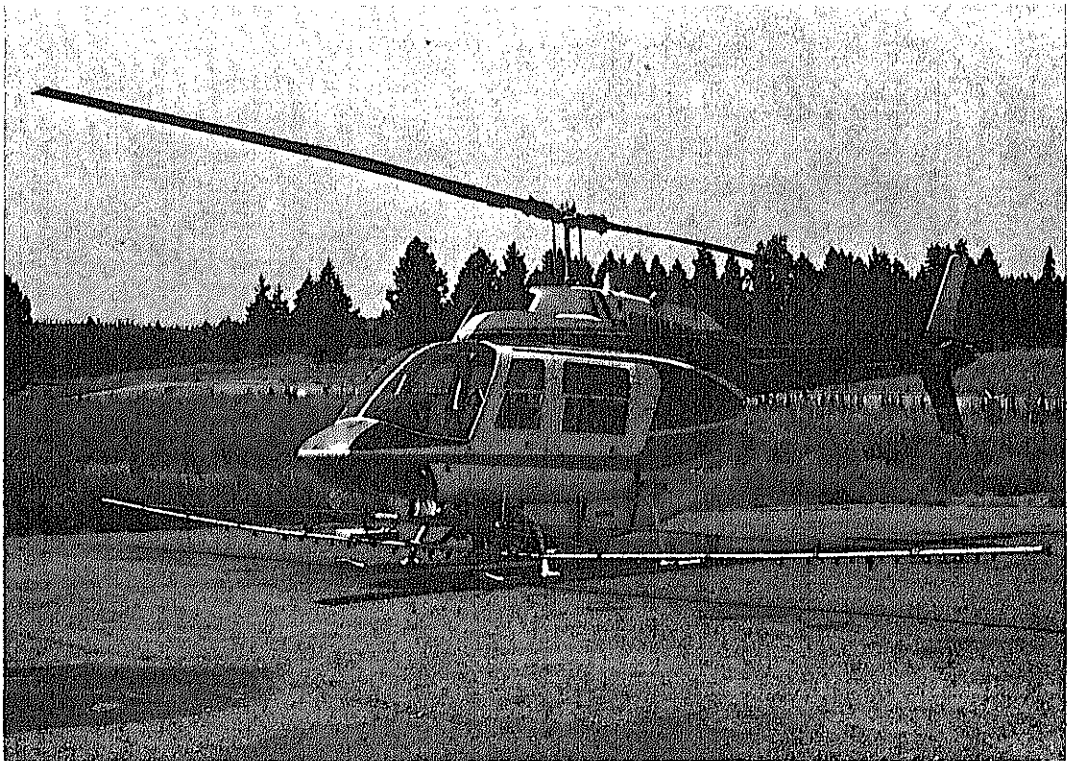
Figure 3. Bell 206B Jet Ranger helicopter with spray system. Turbo Thrush test, Idaho 1978.

We were unsuccessful in locating a helicopter capable of flying 90 mph. We were able to locate a Bell Jet Ranger (Fig. 3), capable of spray speeds of about 70 mph. Faced with the option of conducting the demonstration without a helicopter for comparison, we used the Jet Ranger.

One Bell 206B Jet Ranger owned by Cascade Helicopters, Cashmere, Washington. This was the primary spray helicopter equipped with Simplex spray system - external tank and booms (Fig. 3).

Both aircraft were calibrated at the McCall airport to deliver the one-half gallon per acre. The Jet Ranger (Figs. 3, 7, 8) was calibrated by capturing spray from a nozzle on each end of the spray boom and comparing the captured volume to time. The Turbo Thrush, with a propeller-driven Root pump system (Fig. 9), was calibrated by measuring the volume required to refill the hopper to its original level after one minute of airborne spraying. New Spraying Systems Company nozzles, screens, and tips were used on both aircraft. The Turbo Thrush was equipped with 18 TeeJet Flat Fan 8015 nozzle tips and the Jet Ranger with 28 Flat Fan 8003 tips. In an attempt to achieve a smaller drop size with the Jet

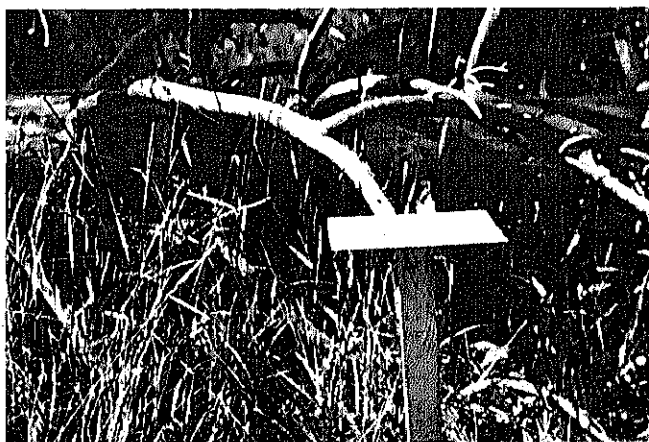
Figure 13. Kromekote card in holder at stake position A-1. A is sampling A and 1 is the first sampler in line A. Turbo Thrush test, Idaho 1978.

Four spray deposit card lines were established in each block (Fig. 6). Lines were 933 feet apart and perpendicular to the expected flight path. A sample site (Fig. 13) was selected every 75 feet along each card line unless the point fell on or within one foot of a tree trunk,

in which case the site was moved a foot or two in any direction. Clinometers were used for slope compensation so the distance between sample sites was a horizontal distance, not a slope distance. At each sample site a 1 x 2-inch wooden stake, three feet high, was used to hold a deposit card sampler. The card line number and sample number were marked on each stake. Standard Kromekote spray deposit cards were positioned just before spray application (Fig. 13).
